EXHIBIT 1

Re: Notification of Incident and Claim for Damages under the Federal Tort Claims Act –
Honolulu Board of Water Supply

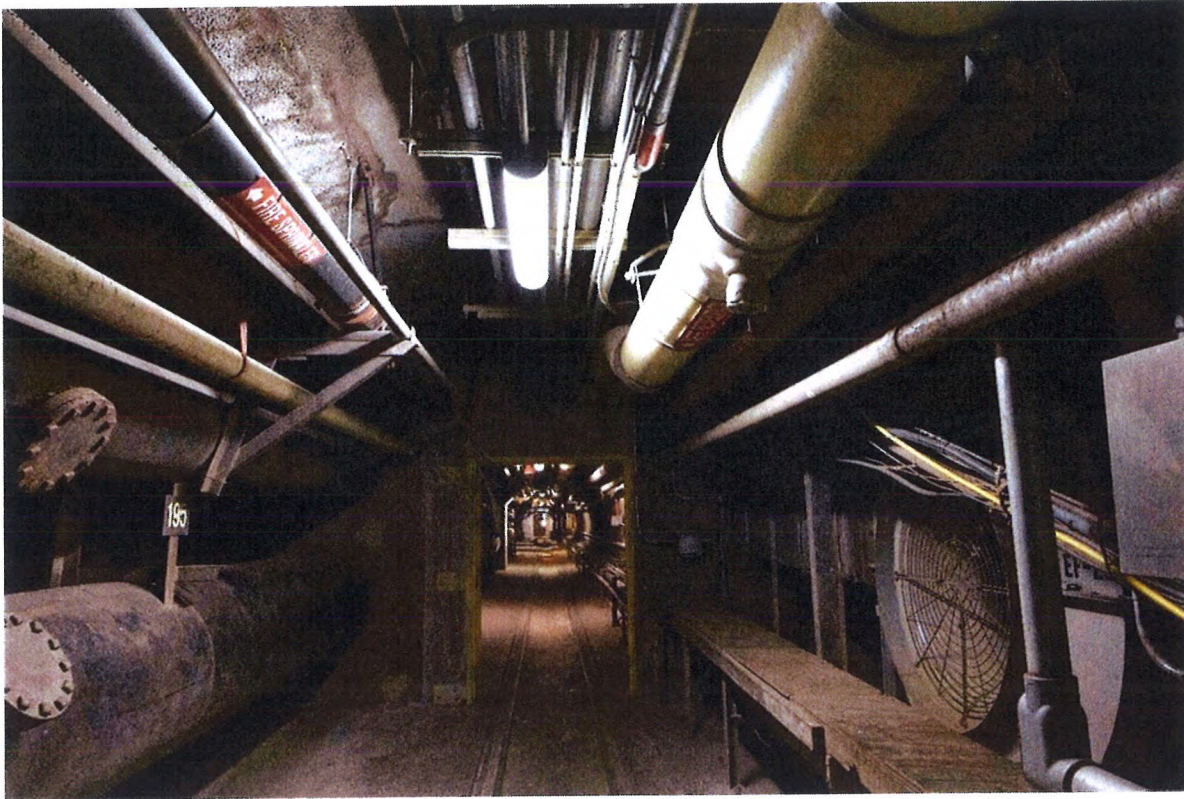
Lower Access Tunnel with AFFF retention line in top right (PVC pipe)

5. The entrance to the pump station is located (b)(3)(A) and 380 feet from the site of the ruptured Aqueous Film Forming Foam (AFFF) retention line low point drain inside the Red Hill lower access tunnel. The top of the well shaft is approximately (b)(3)(A) from the entrance of the pump station. [Encls (7), (9)]
6. Water is pumped from a 110-foot deep vertical well shaft with a bottom elevation of (b)(3)(A) sea level. [Encl (12)]
7. The well includes a horizontal water tunnel, known alternatively as a development tunnel or infiltration gallery, which is connected approximately 100 feet down the vertical well shaft. This horizontal developmental tunnel extends across the water table (b)(3)(A). [Encls (4), (12)]
8. The bottom of the development tunnel is 3 feet below sea level and is 18 feet high by 6 feet wide. (b)(3)(A) [Encl (12)]

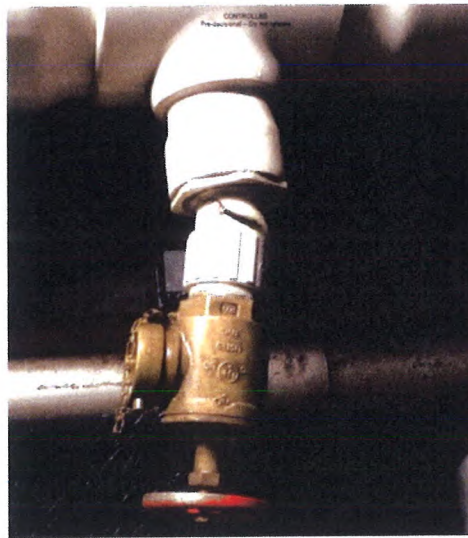
As established in the Cavanaugh Report and updated herein, the AFFF fire suppression system retention line held up to 19,377 gallons of JP-5 fuel from the time of the May spill until the November spill, when a watch stander inadvertently struck a low point drain with the passenger cart of a train, cracking the pipe and spilling the fuel. The below findings of fact focus on the design, installation, induction, and maintenance associated with the AFFF retention line, sump pumps, tank and associated equipment (collectively referred to here as the AFFF waste system).

Cracked Low Point Drain

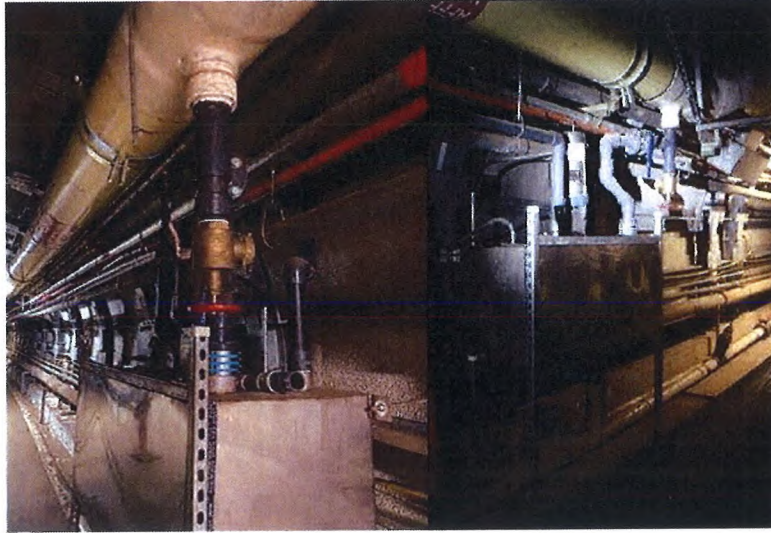
drainage out to a new manual hose connection at the Adit 3 entrance via new 3" PVC piping. This system does not utilize the groundwater sump system. This is the installed configuration today and is in close proximity to the Adit 3 groundwater sump, but does not connect with that sump. This system was not used to drain the AFFF retention line following the November spill. [Encl (354)]

Final Installed Low Point Drain System with PVC Retention Line

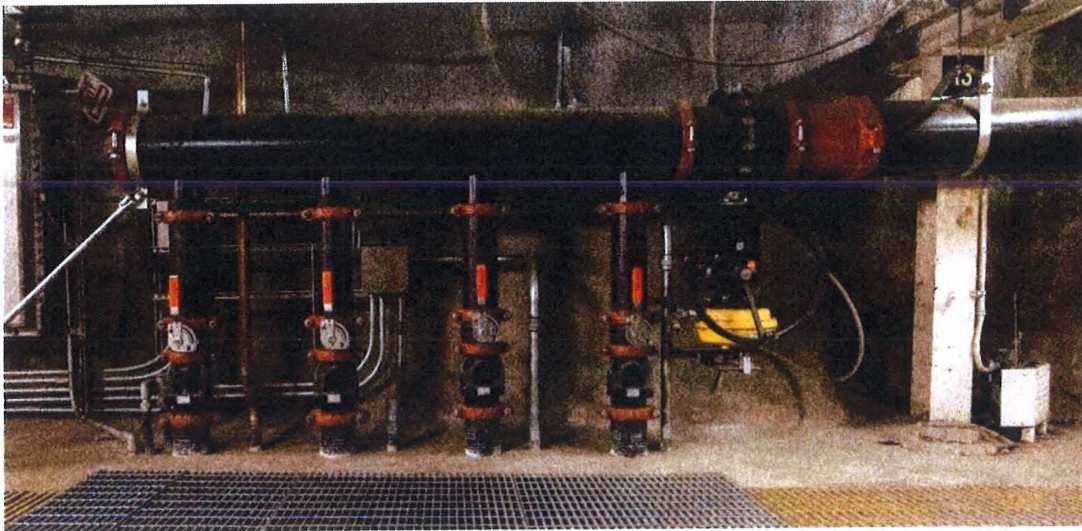
405. On 19 Jun 19, Change R was completed by the construction contractor. This is the configuration today. Commissioning testing was not performed again on the AFFF waste system. However, servicing was performed on the sump pumps (grease, rotation, cleaning) during connection of the new steel piping in the immediate area of the pumps. It was noted at the time that some of the pumps were seized due to lack of preventative maintenance, but were operational at the completion of servicing. [Encls (332), (362), (364)]

Final Change R Piping in Immediate Area of an AFFF Sump

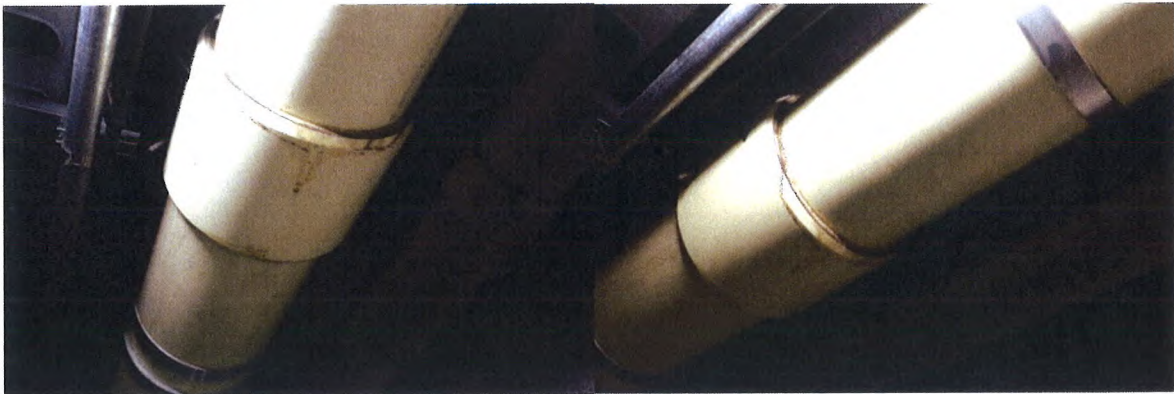
414. On 17 Mar 22, during a walkthrough of Red Hill, the supplement investigation team noted visual evidence of a foreign substance on the outside of the PVC AFFF retention line piping joints that appears to have seeped out.

Installed PVC AFFF Retention Line with Joint Seepage

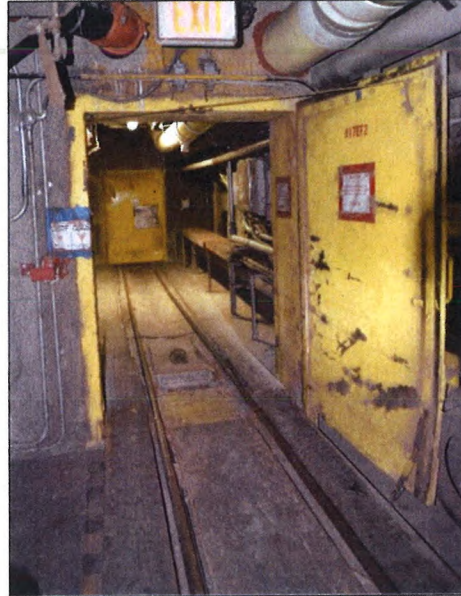
Figure 1: Image of open oil-tight door (foreground) and closed ventilation door on either side of the damaged fire suppression system low point drain valve. [Encl (169)]

178. After driving through the doorway, he again stopped the train and disembarked to close the ventilation control door. As he turned to close the door, he discovered liquid spraying from the low point drain of the fire suppression system retention line. He reported the leak immediately to the CRO. He recognized the source was a non-fuel system, first reporting it was from a sewage line, then fire suppression agent, then water. Finally, he reported the leak as water with a fuel smell. This line should have been empty. [Encls (83), (173)-(186)]
